Building 881 Complex Environmental Compliance Issues Relating to Building Shutdown

The week of May 4, 1998 auditors from Proctor's Enterprise, at the request and direction of Kaiser-Hill, conducted a building walkdown and record review of the Building 881 complex. This audit was to determine what actions relating to environmental compliance need to be conducted prior to placing the building in shutdown. The Building 881 Complex is located at the east of RFETS. Building 881 is the largest building in the complex and is supported by buildings T881A, T881B, 881F, 881G, 881H, 830, 864, 885, and 887. Buildings 881, 885, 887, 881F, 881G, 881H, and 830 were included in this assessment.

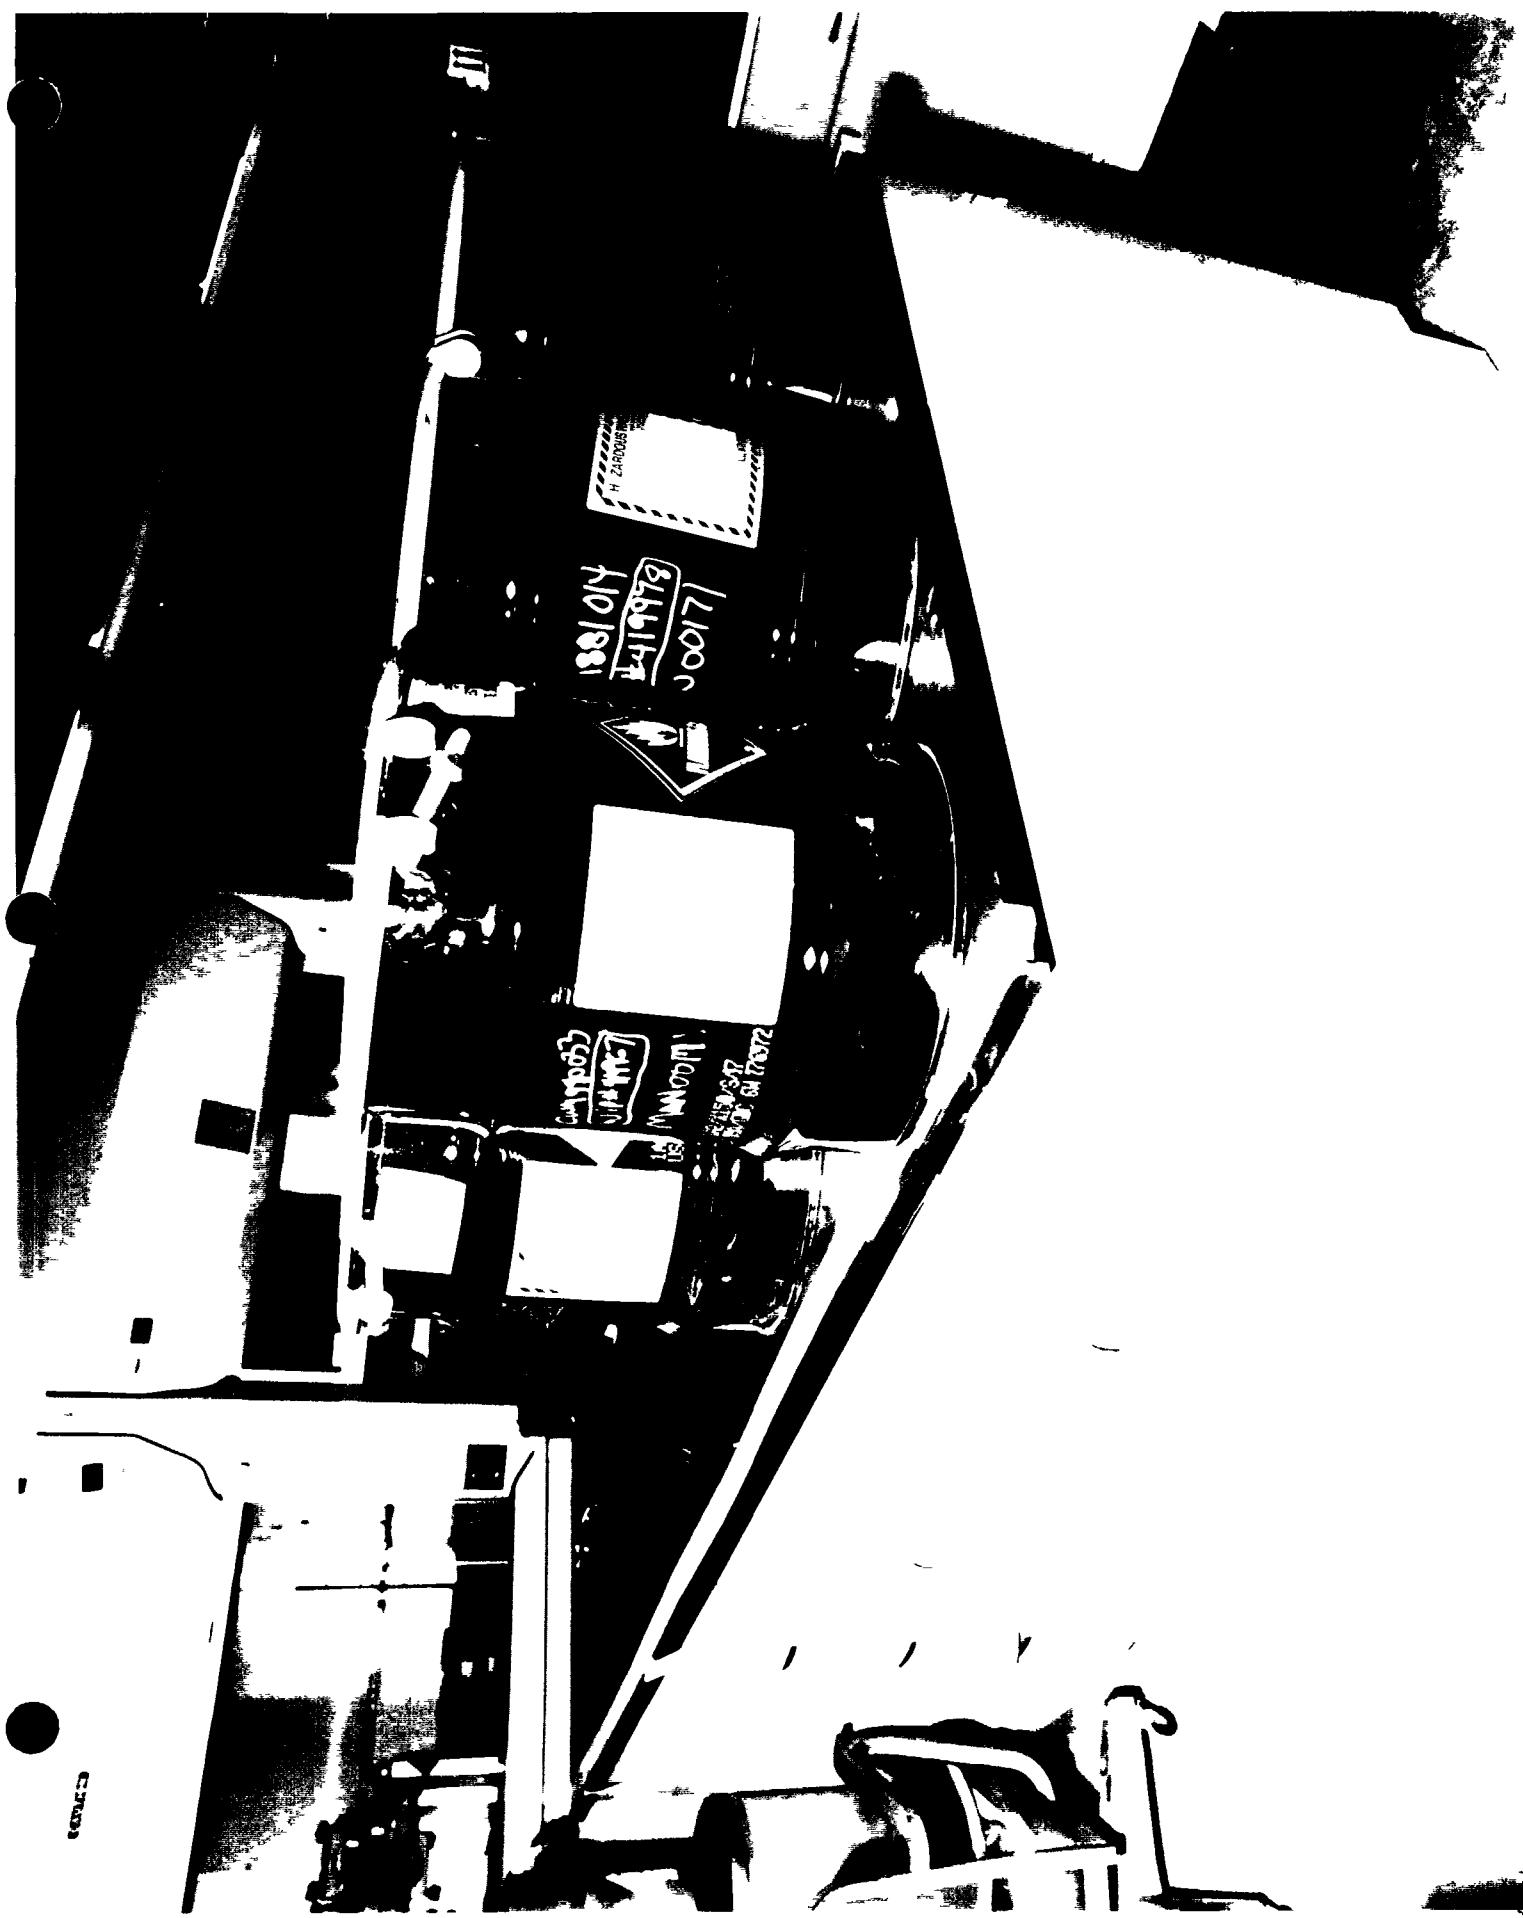
Bldg 881 Room 296 90 d/w RCR A Storage Unit 881 2429 showing waste containers Photograph
#60692 07 5/5/98

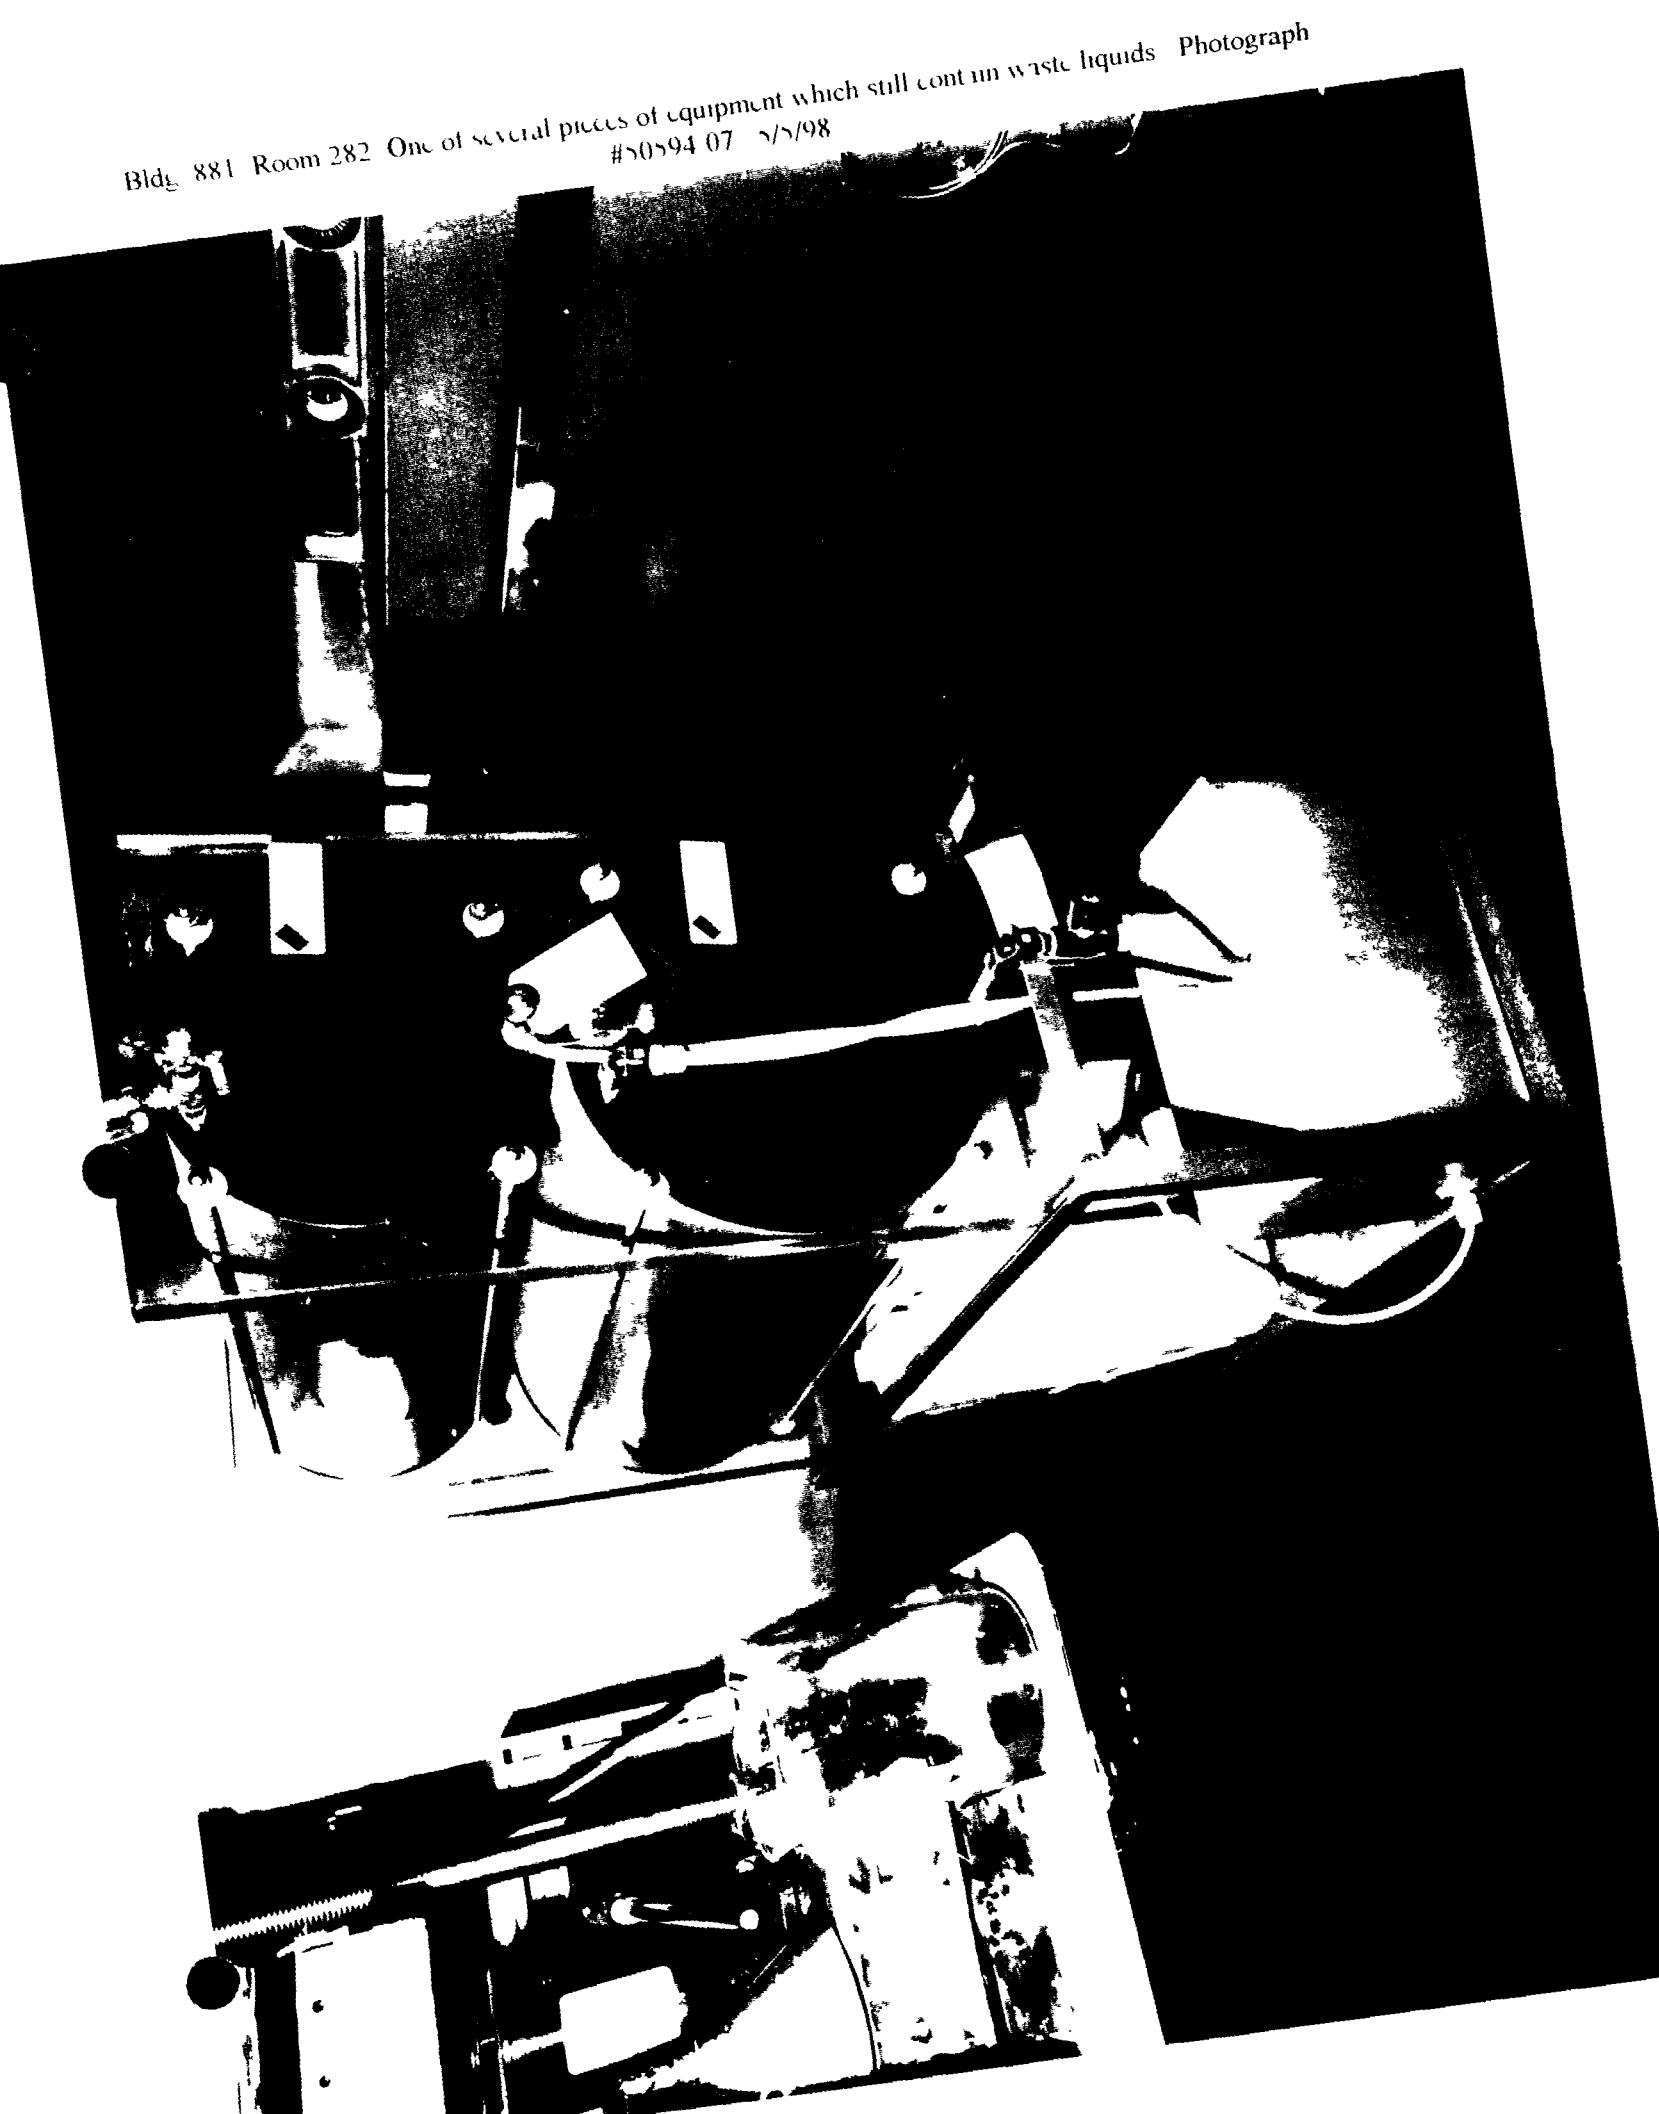
Regulatory deficiency Compliance Order on Consent 97-08- 21-01 Idle Equipment Management Plan	K-H RMRS	Idle Equipment	<p>There are thousands of pieces of equipment that will have to be inventoried, evaluated under the PU & D process and the hazardous waste regulations and properly dispositioned</p> <p>Some of the equipment still have liquids associated with them e.g. Room 282, 272, 127B, and 233 contain equipment with auxiliary containers which contain liquid that could readily be spilled. Room 127B contained a burret with what appear to be charcoal and water</p>	<p>Conduct inventory of all excess equipment and manage in accordance with the Idle Equipment Management Plan</p> <p>Drain and characterize all liquids associated with equipment</p> <p>Discussions with Don Clark, RMRS Henry Padron, RMRS, Dennis Mauser, RMRS, and Ken Fry, RMRS, on May 5, 1998</p> <p>Exhibits</p> <p>Photographs 50591-07, 50591-10, 50592-03, 50592-05, 50593-03, 50593-04, 50593-05, 50593-06, 50593-07 and 50594-07</p>	<p>Building walk down conducted May 4 and 5, 1998, Bob Cathel, K-H, Cheryl Saylor, Proctor's Enterprise (PE), Kim Myers, PE, Catherine Alstatt, PE, and Dennis Mauser, RMRS</p> <p>Exhibits</p> <p>Photographs 50591-07, 50591-10, 50592-03, 50592-05, 50593-03, 50593-04, 50593-05, 50593-06, 50593-07 and 50594-07</p>

Bldg 881 Room 282 One of several pieces of equipment which still contain waste liquids Photograph
#70594 07 7/7/98

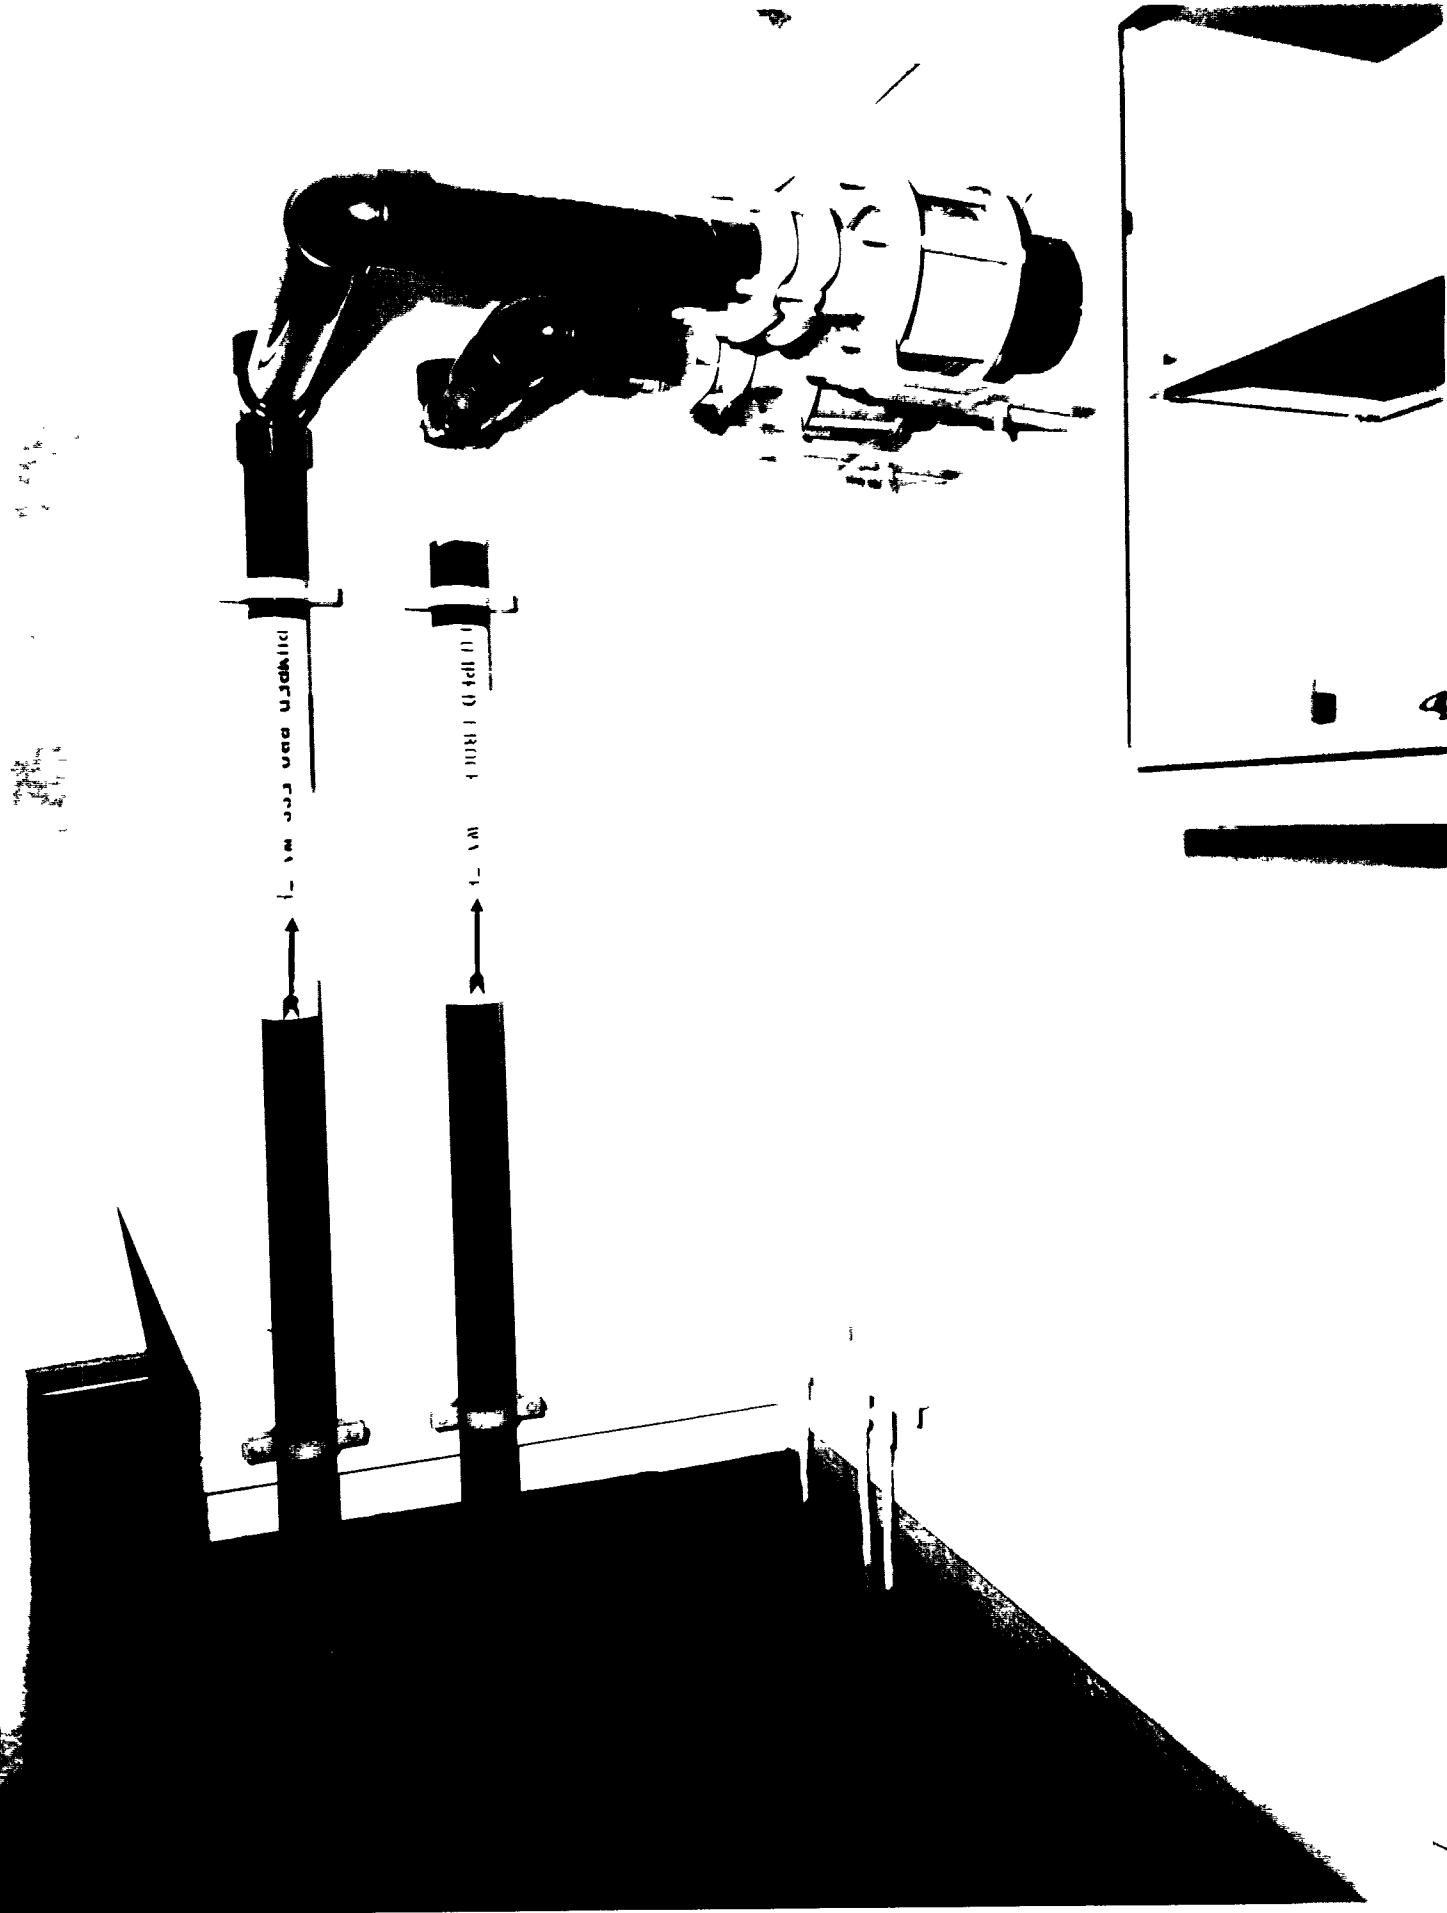
Bldg 881 Room 309G Pumped Process Waste lines which have leaked in the past Photograph
#50594 10 5/5/98
